⁽⁶⁾
METALLURGICAL CHANGES IN THE HIGH
TEMPERATURE FRETTING OF Ni and Ti
ALLOYS

⁽⁹⁾ Final Technical Report

⁽¹⁰⁾ R.B. Waterhouse and M.M. Hamdy

⁽¹¹⁾ February 1979

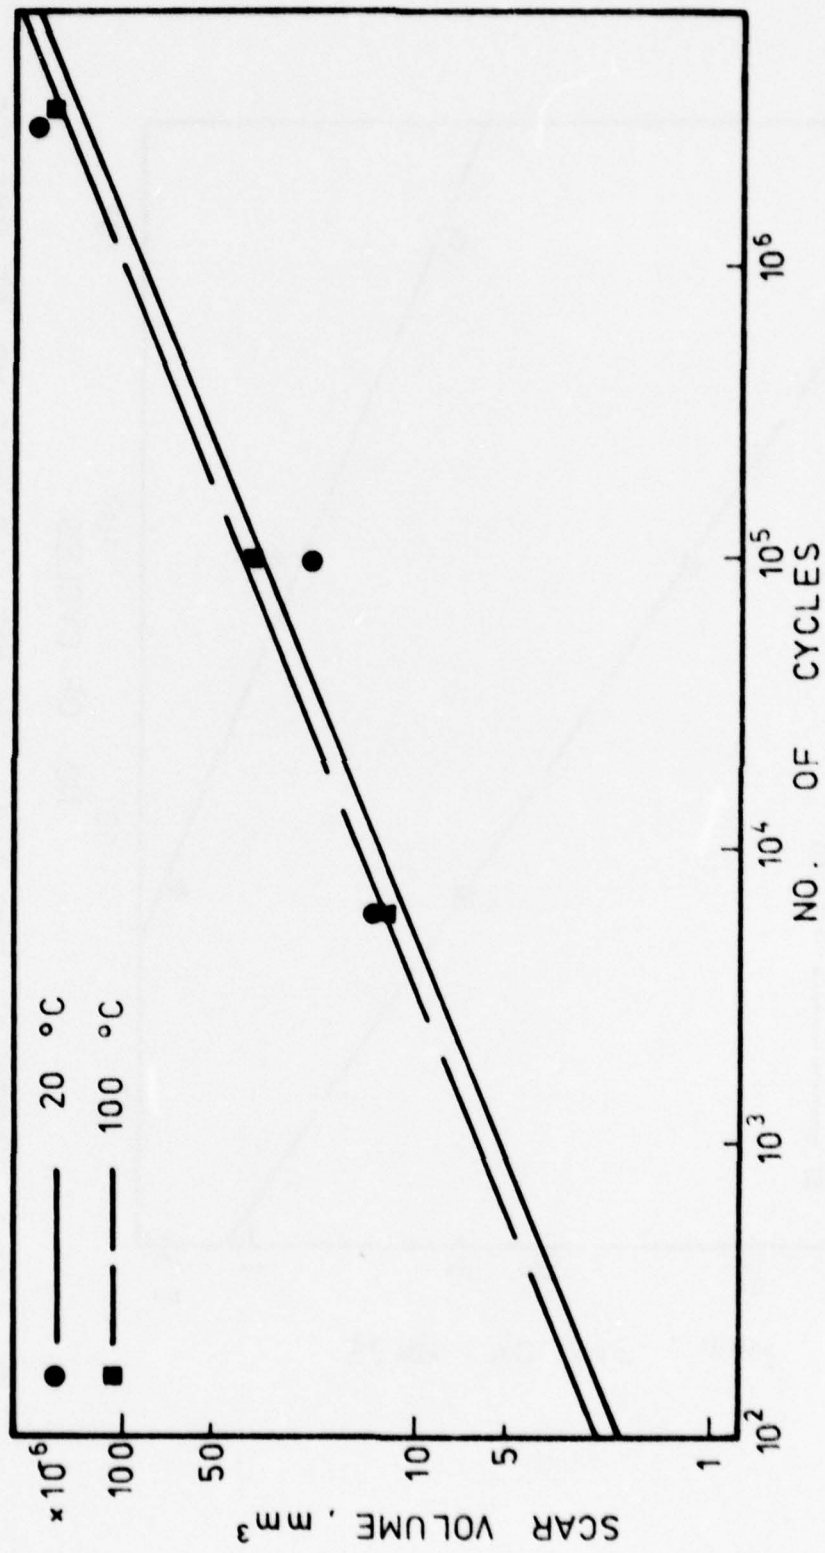
Fig. (37) PLOTS OF THE SCAR VOLUME AGAINST NO. OF CYCLES FOR
Ti-ALLOY (AMMRC) AT 40 μm SLIP AMPLITUDE .

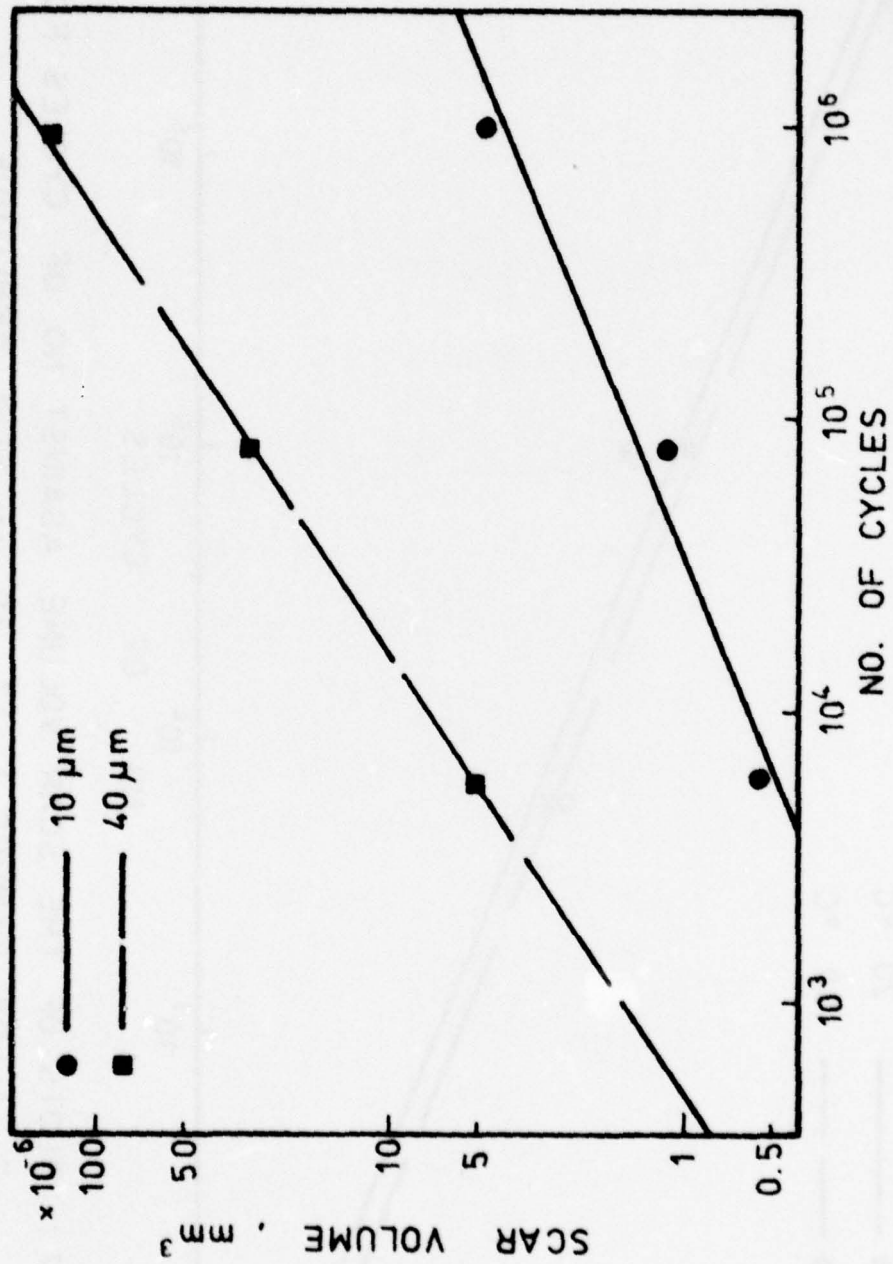
Fig. (38) PLOTS OF THE SCAR VOLUME AGAINST NO. OF CYCLES
FOR INCONEL ALLOY 718 AT 20 °C.

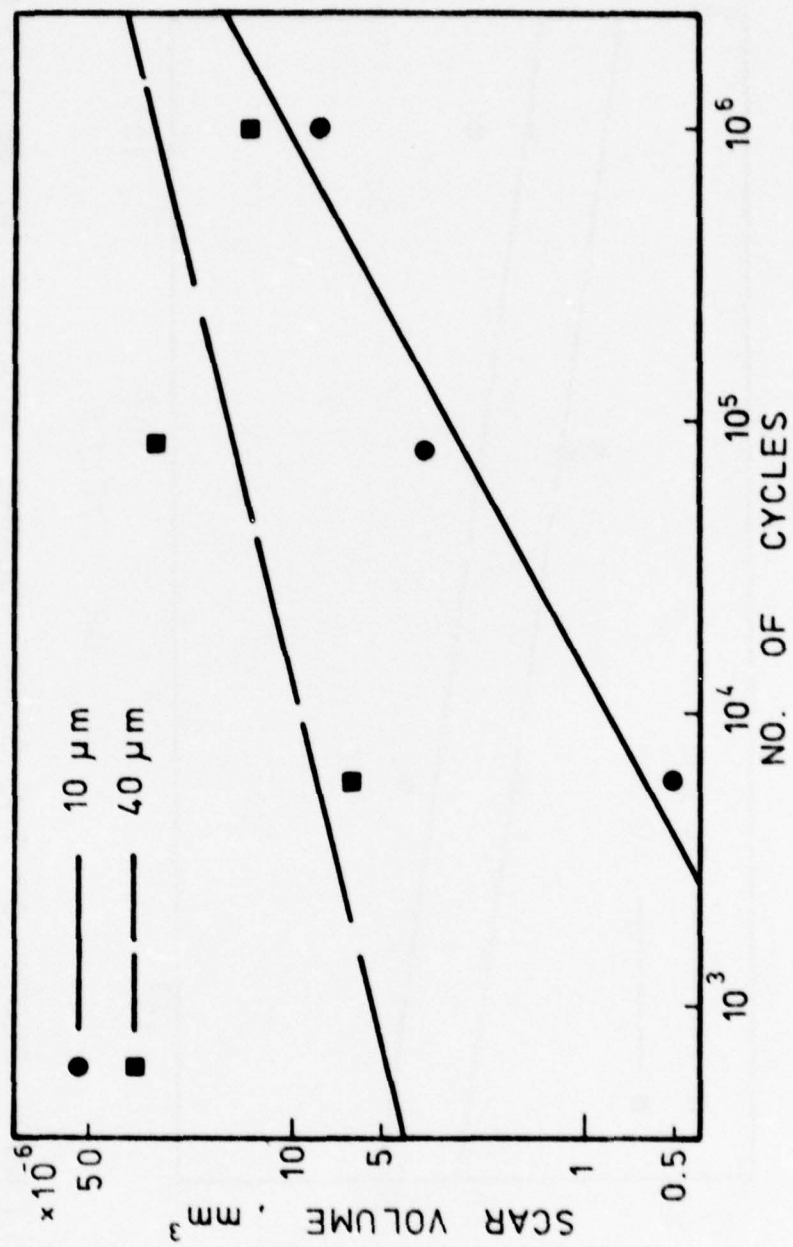
Fig. (39) PLOTS OF THE SCAR VOLUME AGAINST NO. OF CYCLES
FOR INCONEL 718 (AGED) AT 280 °C .

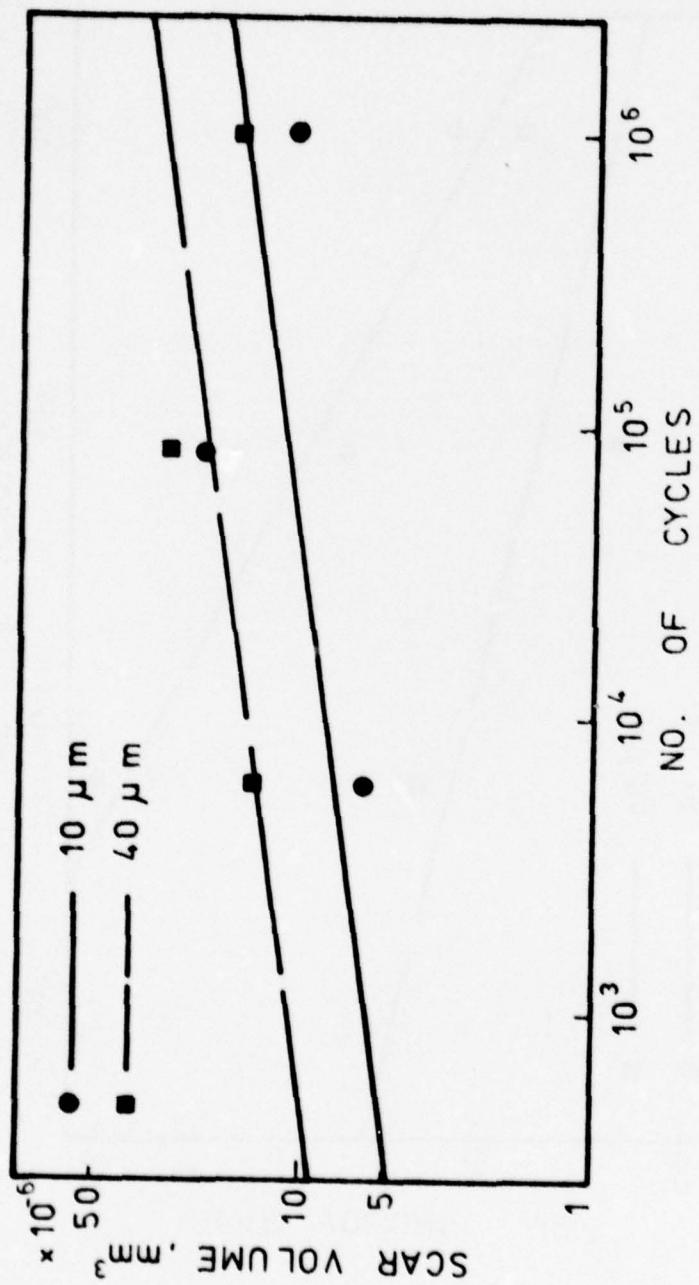
Fig. (40) PLOTS OF THE SCAR VOLUME AGAINST NO. OF CYCLES
FOR INCONEL 718 (AGED) AT 540 °C .

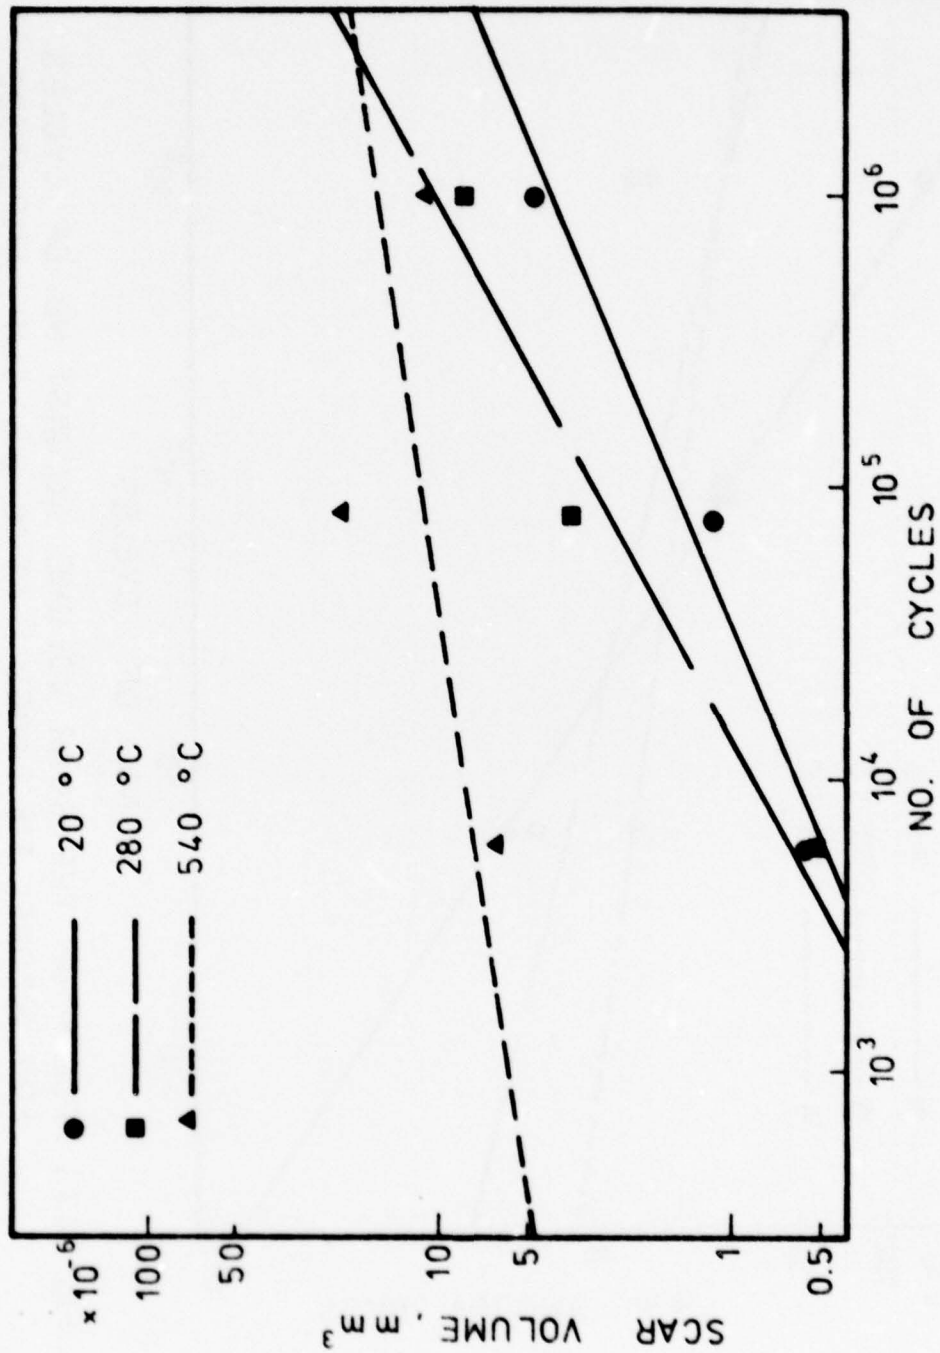
Fig. (41) PLOTS OF THE SCAR VOLUME AGAINST NO. OF CYCLES FOR INCONEL 718 (AGED) AT 10 μm SLIP AMPLITUDE .

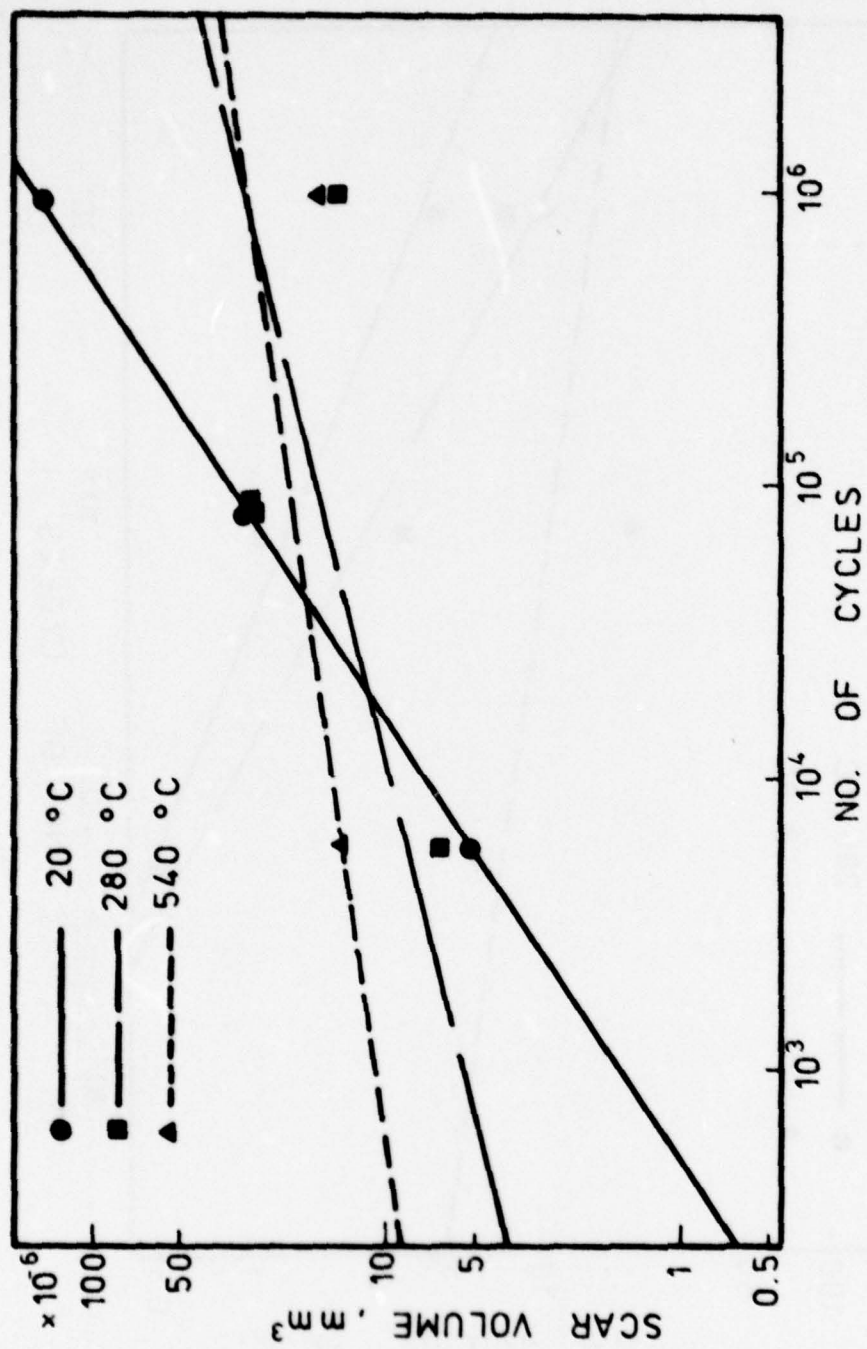
Fig. (42) PLOTS OF THE SCAR VOLUME AGAINST NO. OF CYCLES
FOR INCONEL 718 (AGED) AT 40 μ m SLIP AMPLITUDE .

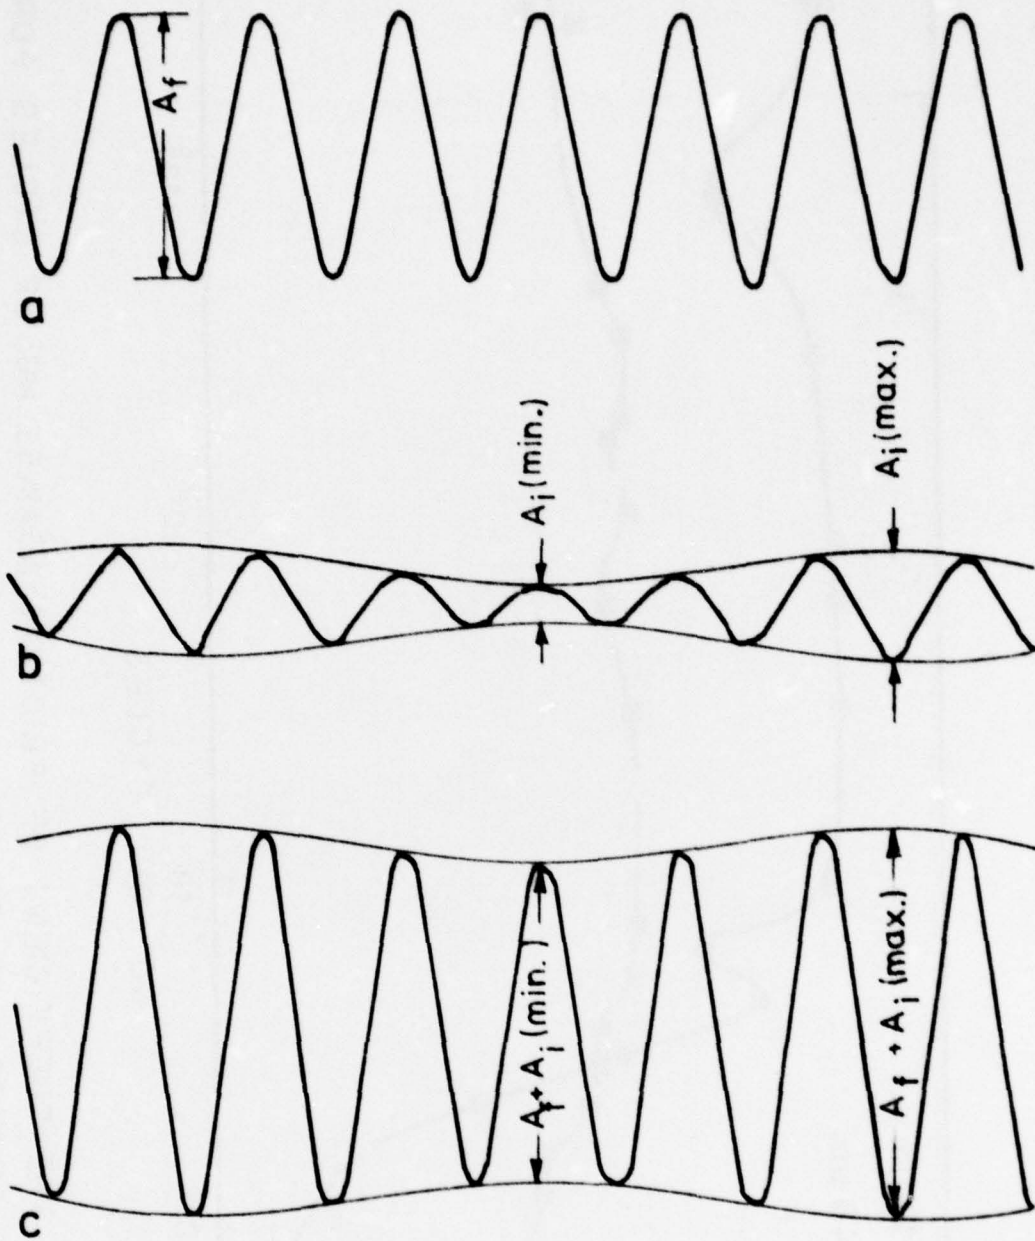
Fig.(43) THE COMBINATION OF THE FRICTION
FORCE AND THE NOISE + INERTIA FORCE
SIGNALS.

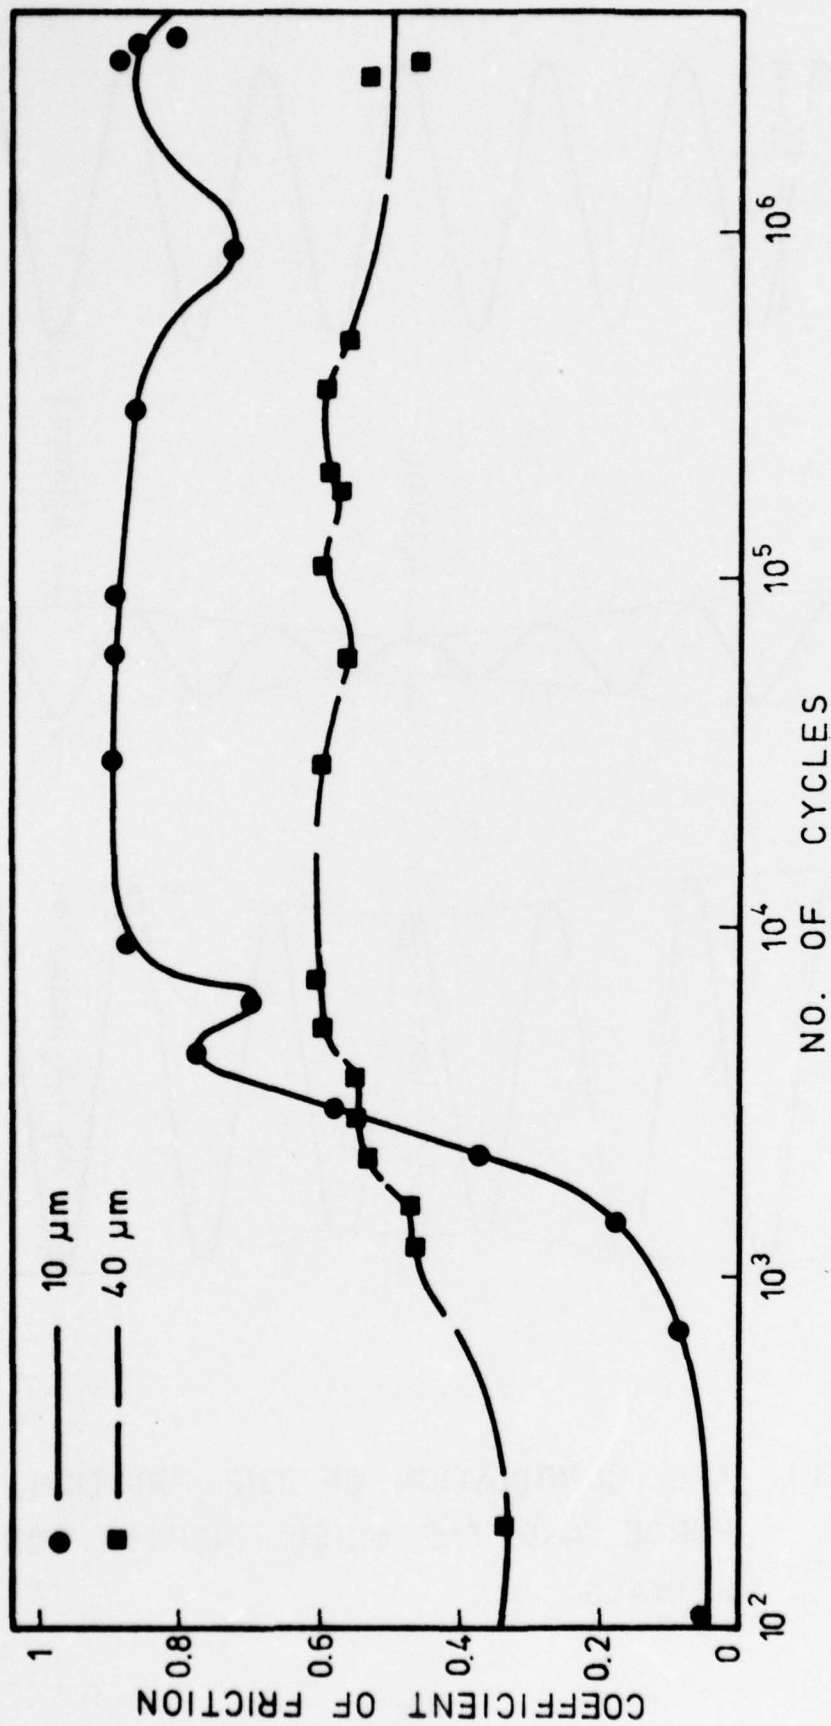
Fig. (44) PLOTS OF THE COEFFICIENT OF FRICTION AGAINST NO. OF CYCLES FOR
Ti - ALLOY (AMMRC) AT 20 °C .

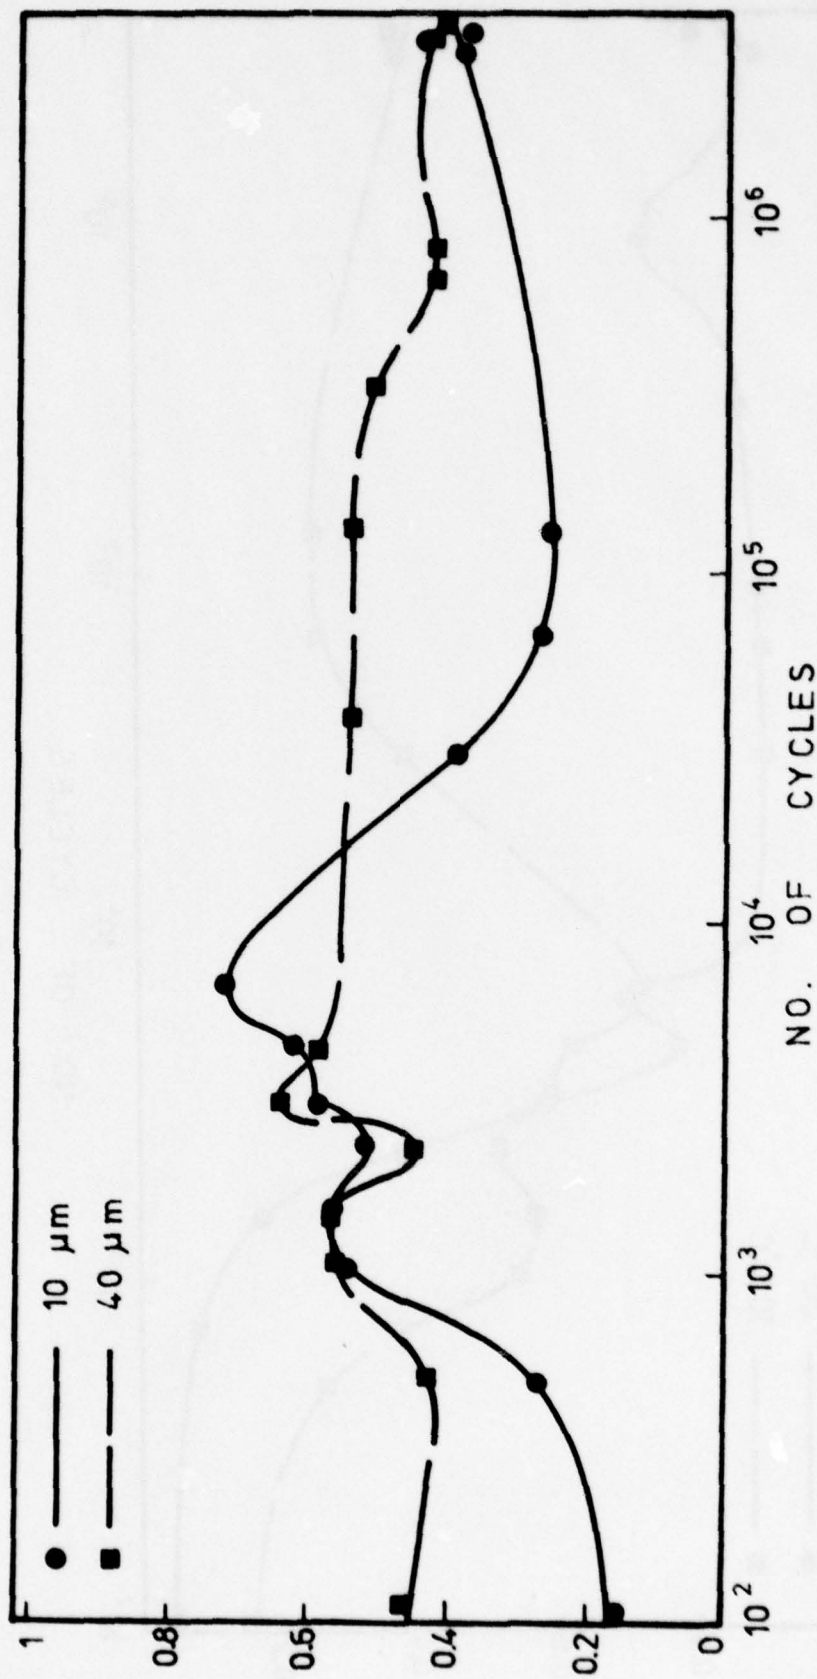
Fig. (45) PLOTS OF THE COEFFICIENT OF FRICTION AGAINST NO. OF CYCLES FOR Ti-ALLOY (AMMRC) AT 100 °C.

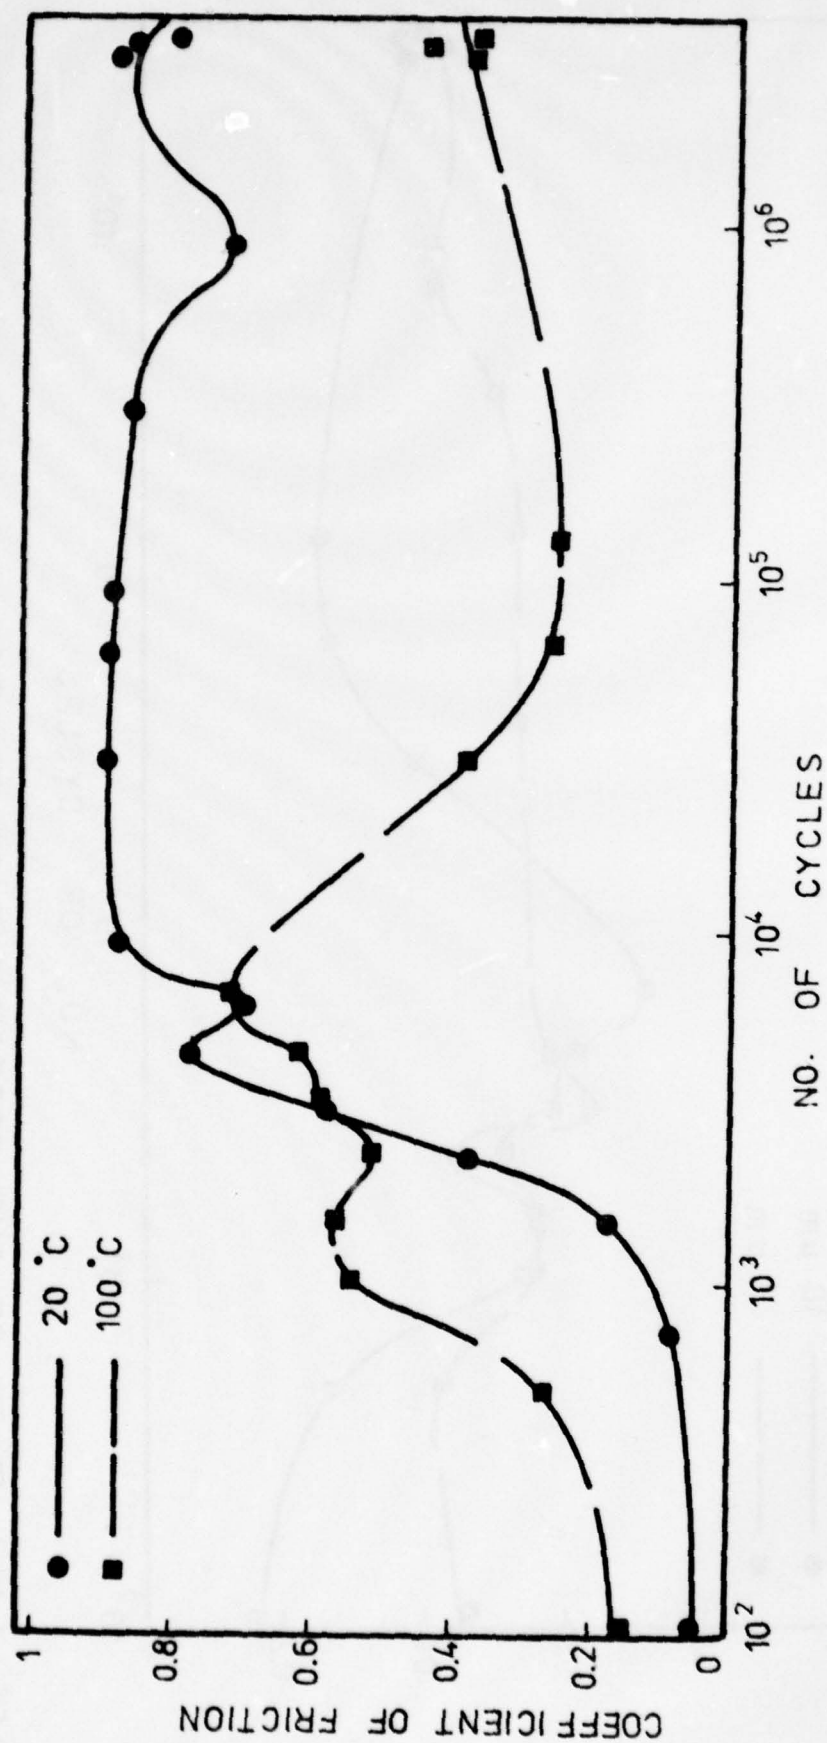
Fig. (46) PLOTS OF THE COEFFICIENT OF FRICTION AGAINST NO. OF CYCLES FOR Ti-ALLOY (AMMRC) AT 10 μ m SLIP AMPLITUDE.

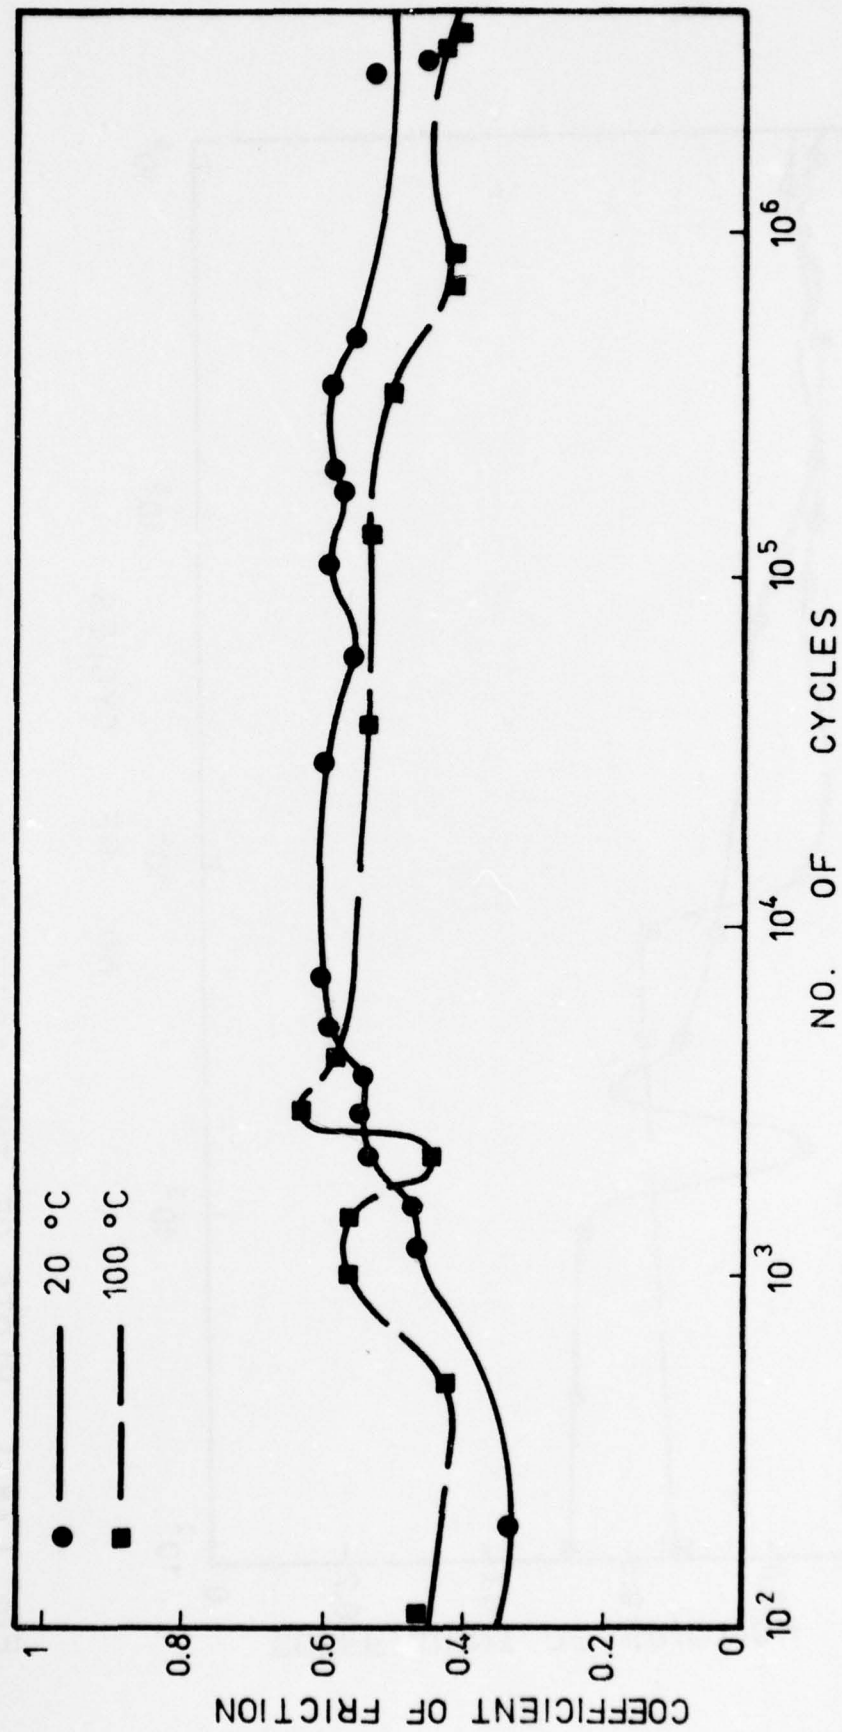
Fig. (47) PLOTS OF THE COEFFICIENT OF FRICTION AGAINST NO. OF CYCLES FOR
Ti-ALLOY (AMMRC) AT 40 μ m SLIP AMPLITUDE.

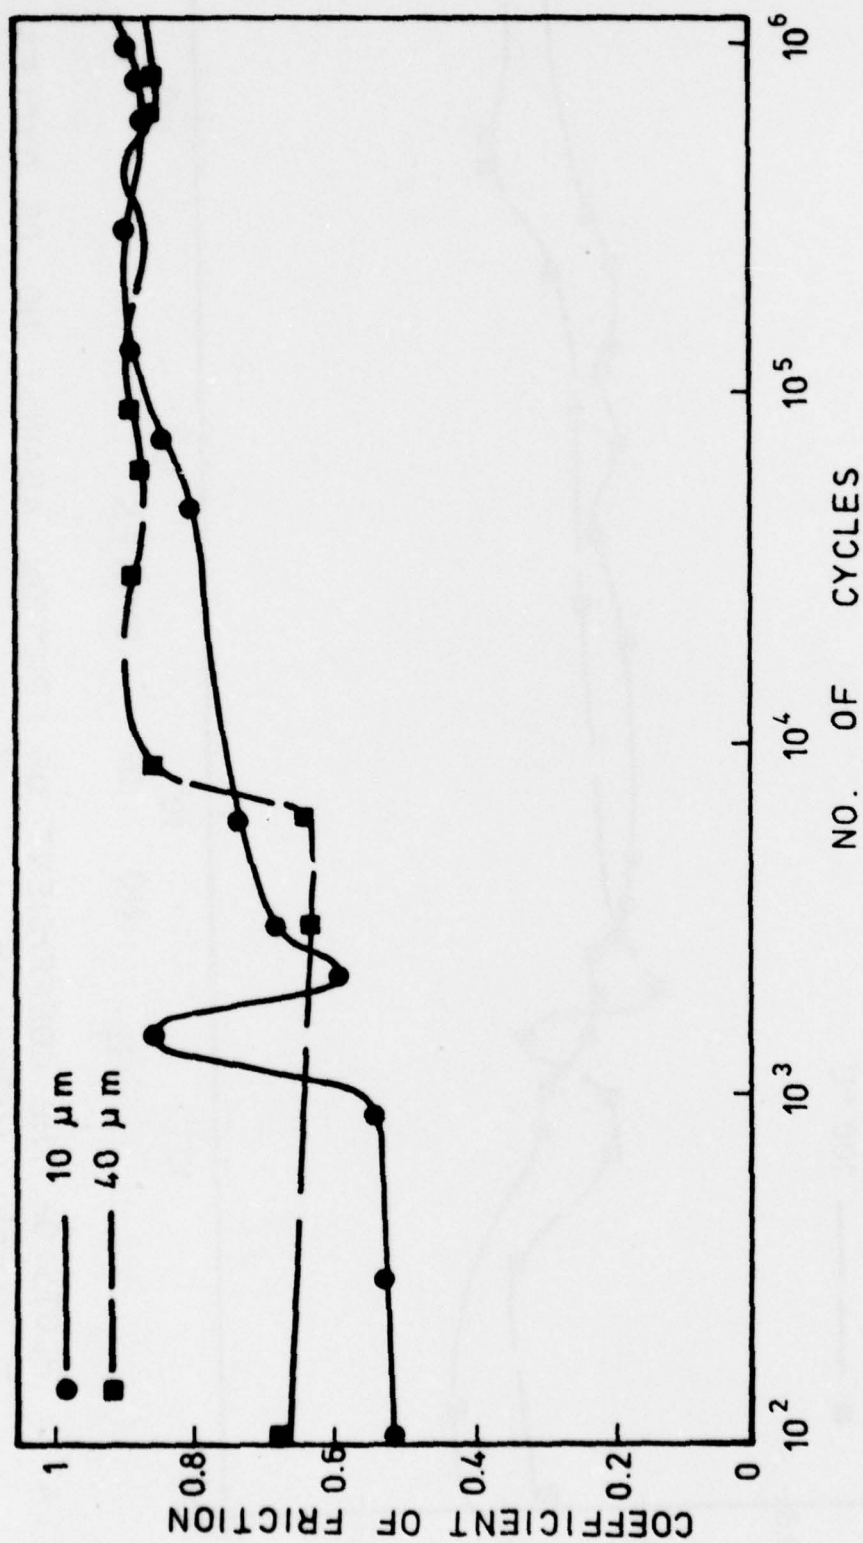
Fig. (48) PLOTS OF THE COEFFICIENT OF FRICTION AGAINST NO. OF CYCLES FOR INCONEL 718 (AGED) AT 20 °C .

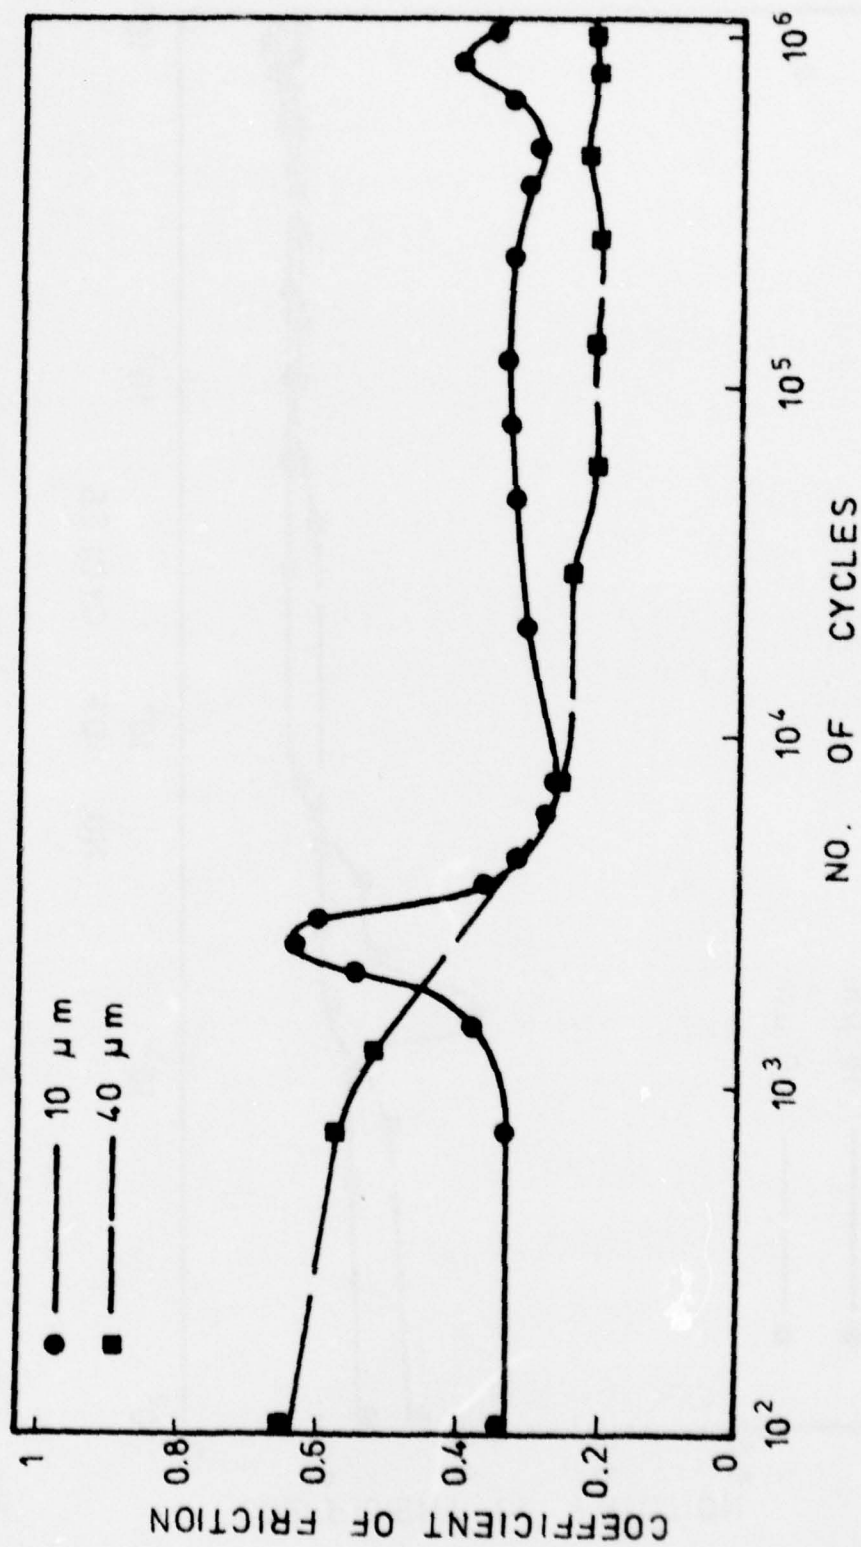
Fig. (49) PLOTS OF THE COEFFICIENT OF FRICTION AGAINST NO. OF CYCLES FOR INCONEL 718 (AGED) AT 280 °C .

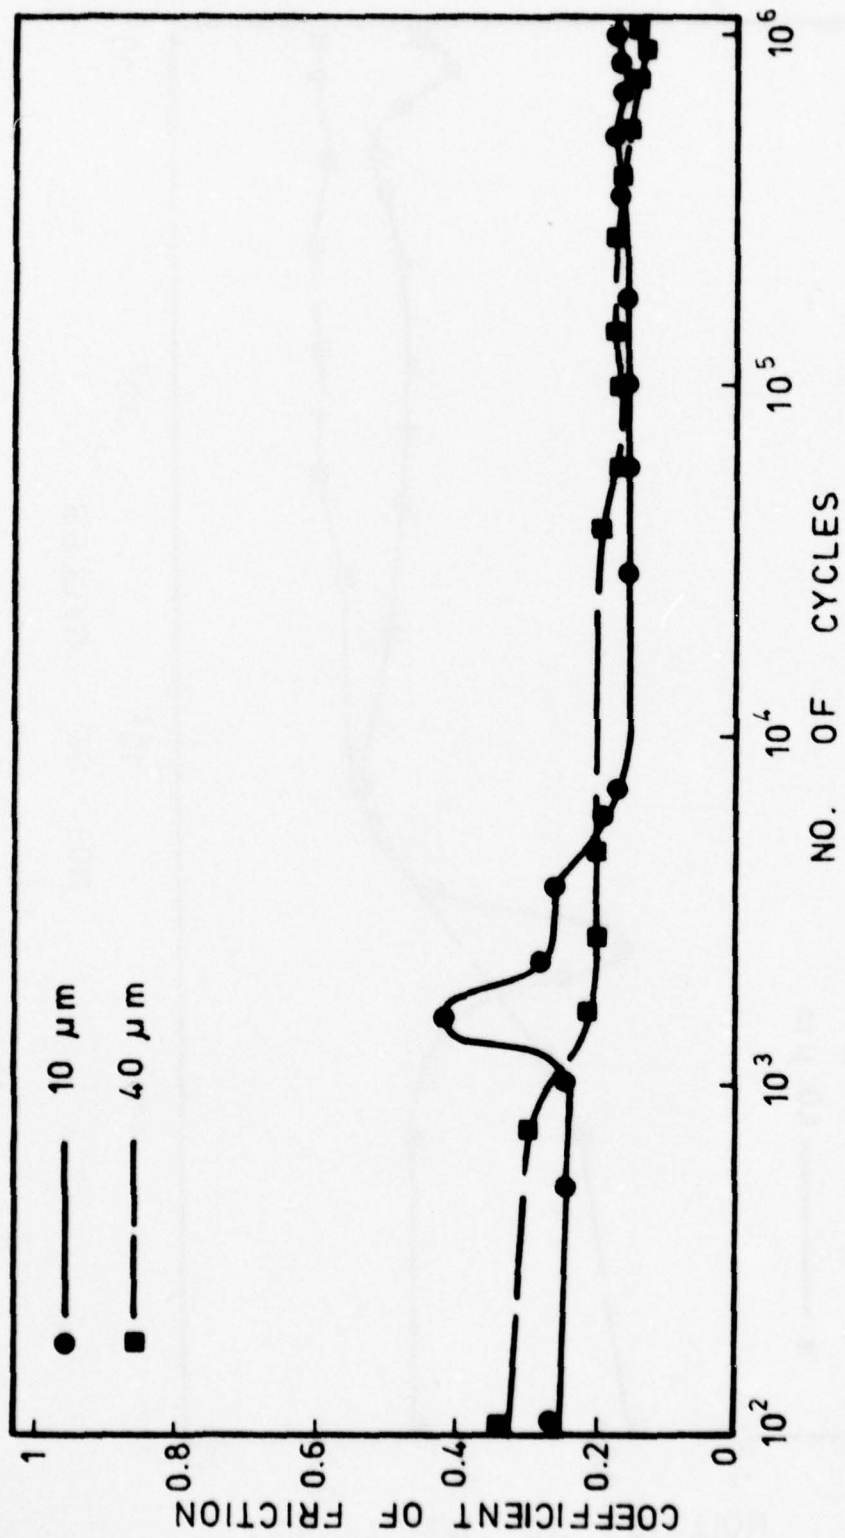
Fig. (50) PLOTS OF THE COEFFICIENT OF FRICTION AGAINST NO. OF CYCLES FOR INCONEL 718 (AGED) AT 540 °C .

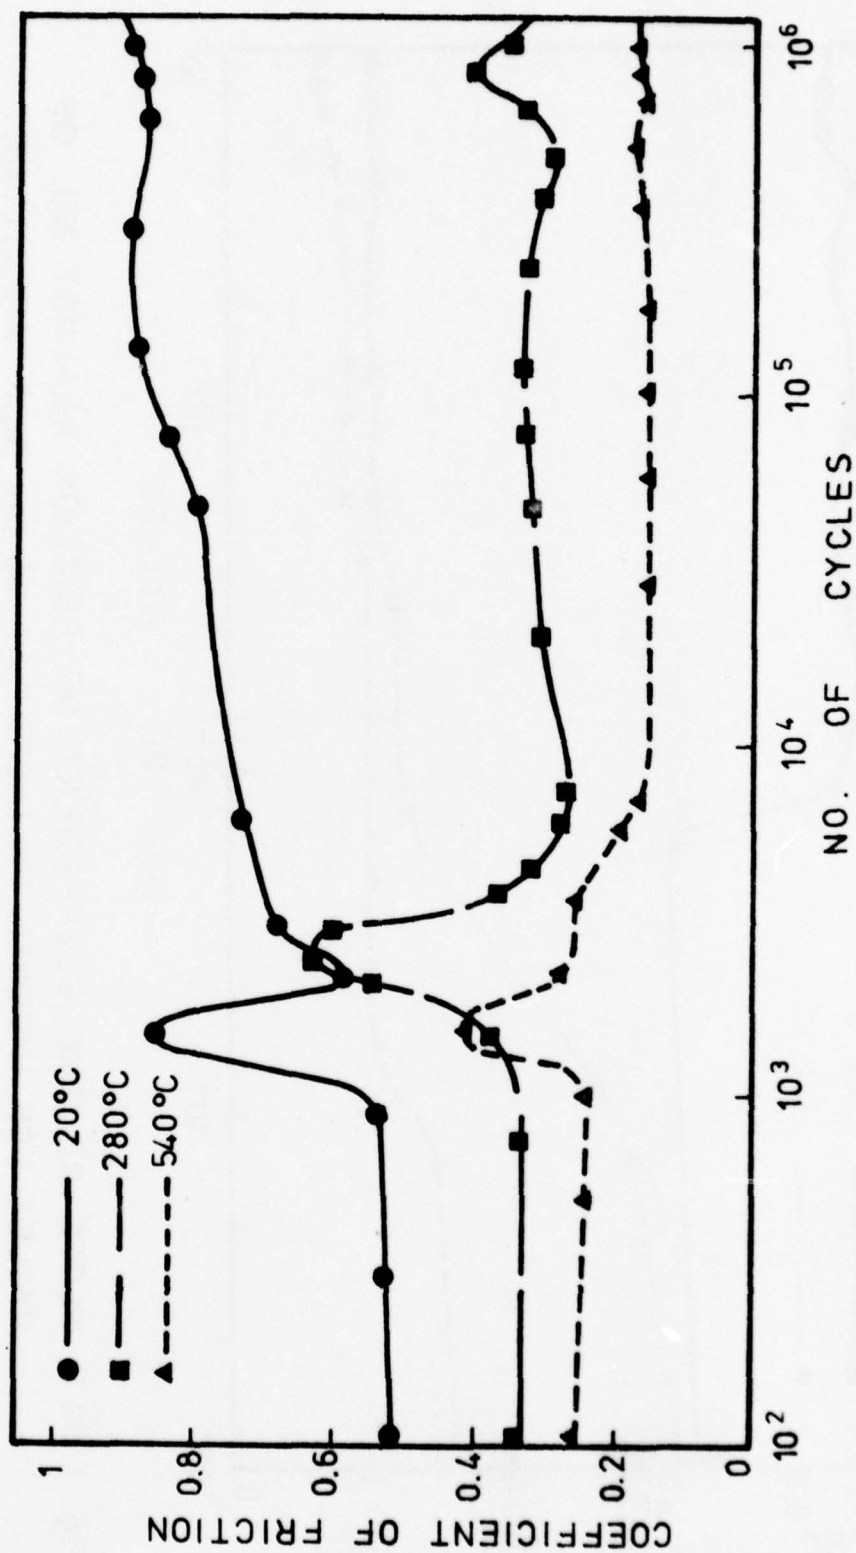
Fig. (51) PLOTS OF THE COEFFICIENT OF FRICTION AGAINST NO. OF CYCLES FOR INCONEL 718 (AGED) AT 10 μ m SLIP AMPLITUDE .

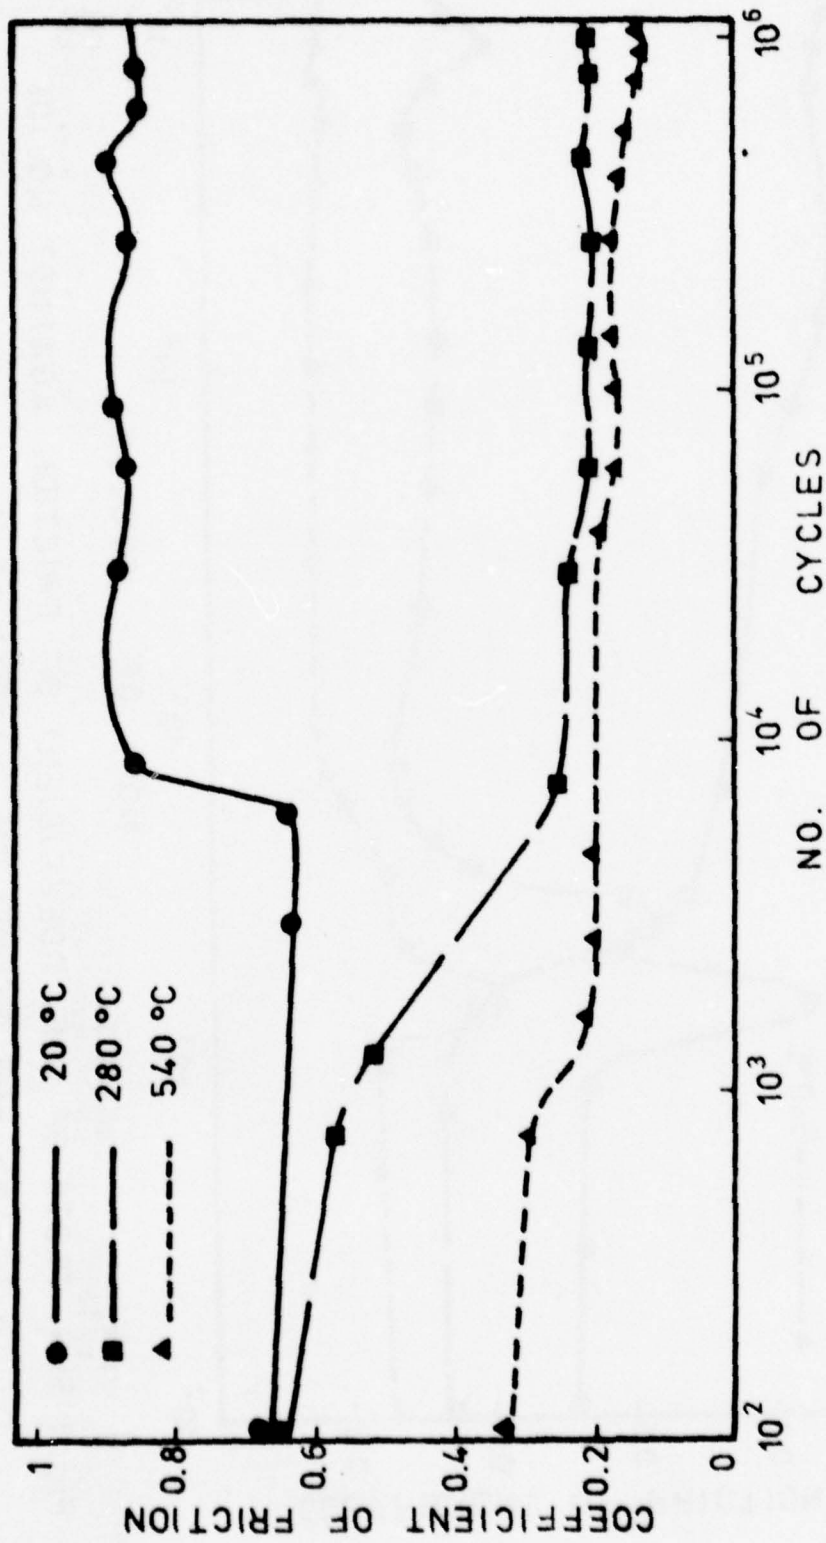
Fig. (52) PLOTS OF THE COEFFICIENT OF FRICTION AGAINST NO. OF CYCLES FOR INCONEL 718 (AGED) AT 40 μ m SLIP AMPLITUDE.

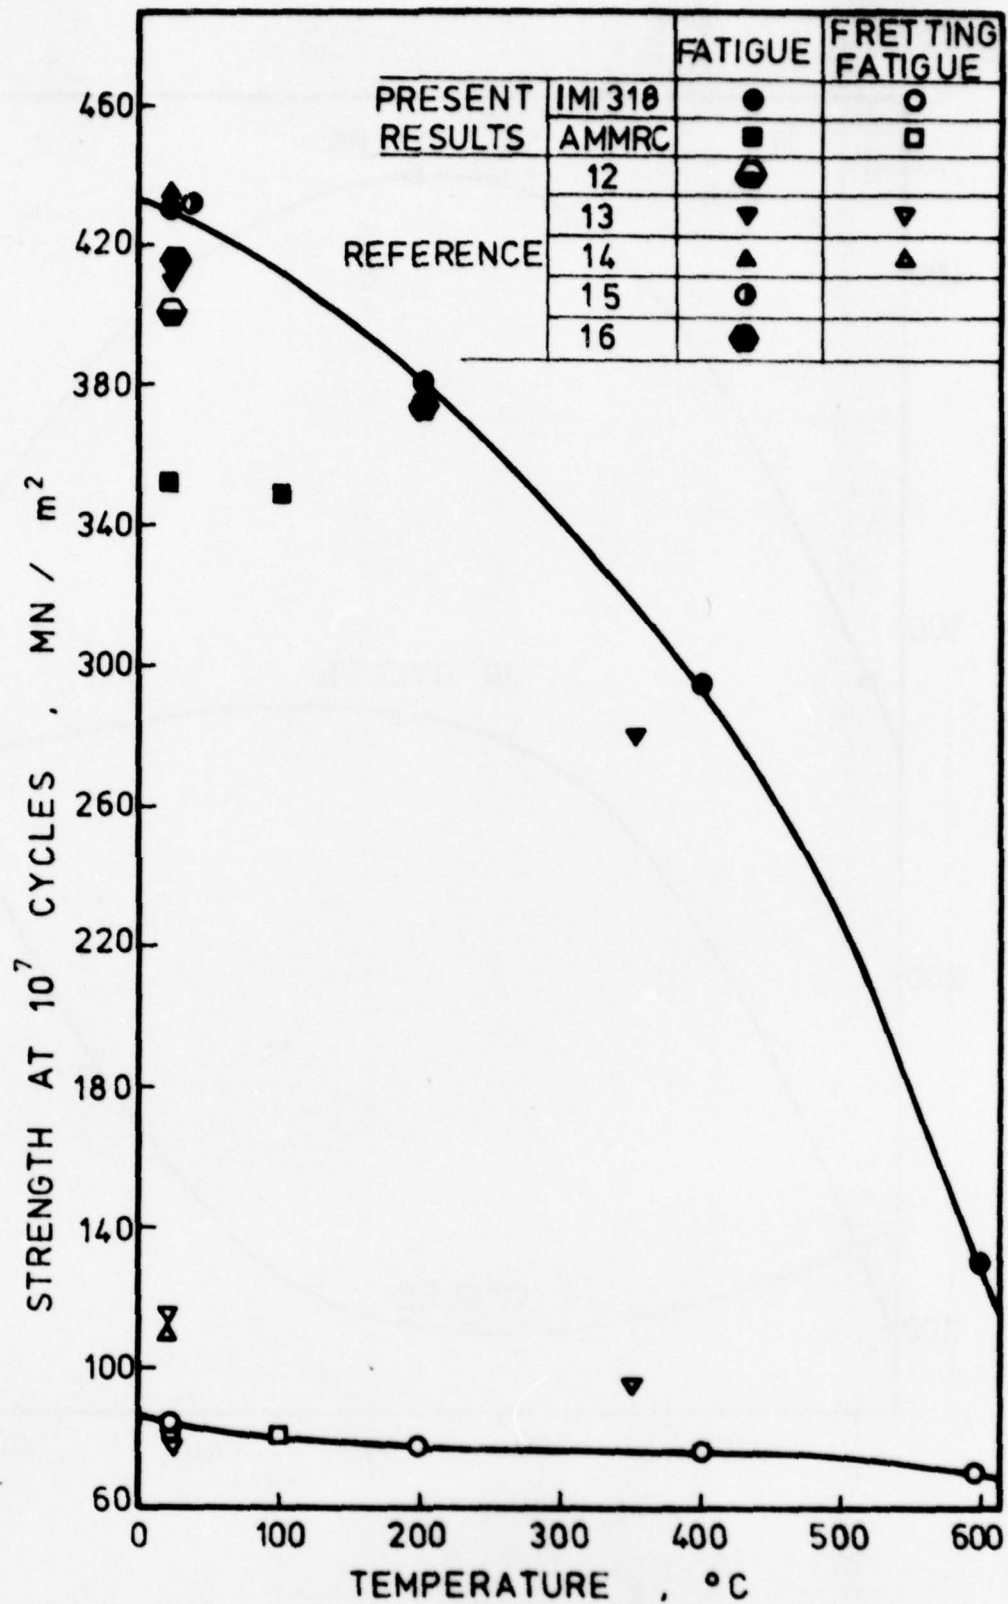
Fig. (53) EFFECT OF TEMPERATURE ON THE FATIGUE AND FRETTING FATIGUE STRENGTH OF Ti-6Al-4V ALLOY.
